Subject: Department of Natural Resources Washington Geological Survey,
School Seismic Safety Assessment Project, Contract No. AE 410 -
Seismic Evaluation for **Tacoma School District**

School Buildings Evaluated in the Tacoma School District

1.1 Building Description

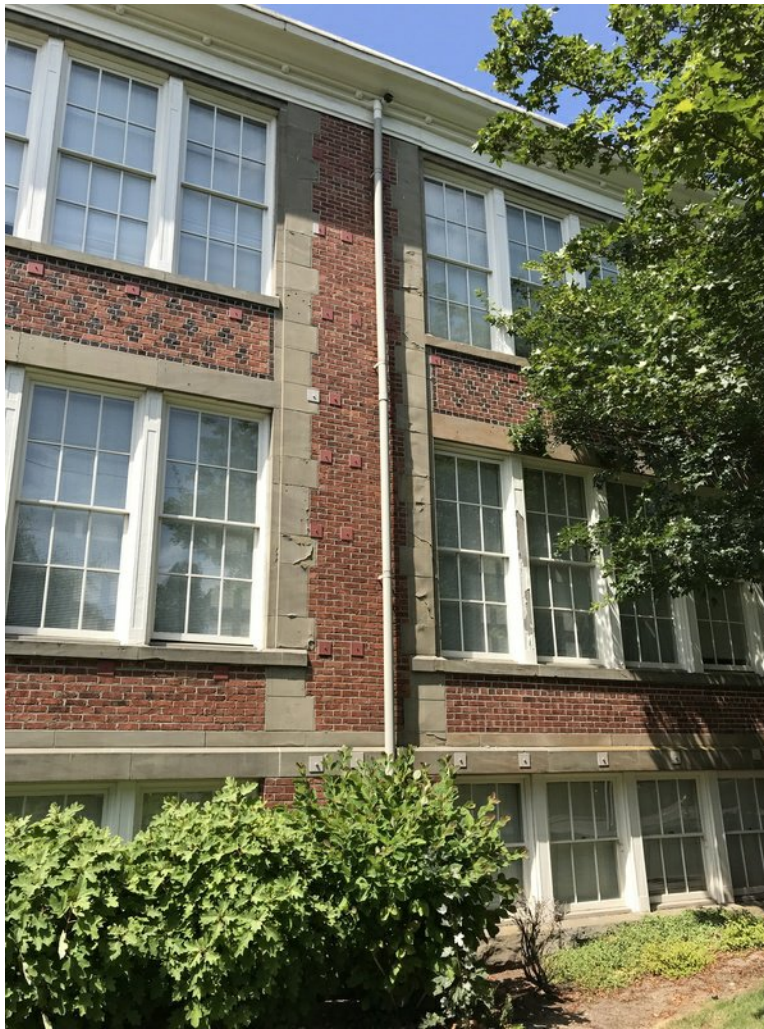
Figure 1-2. Fern Hill East Side - Rosettes tying unreinforced masonry wythes together

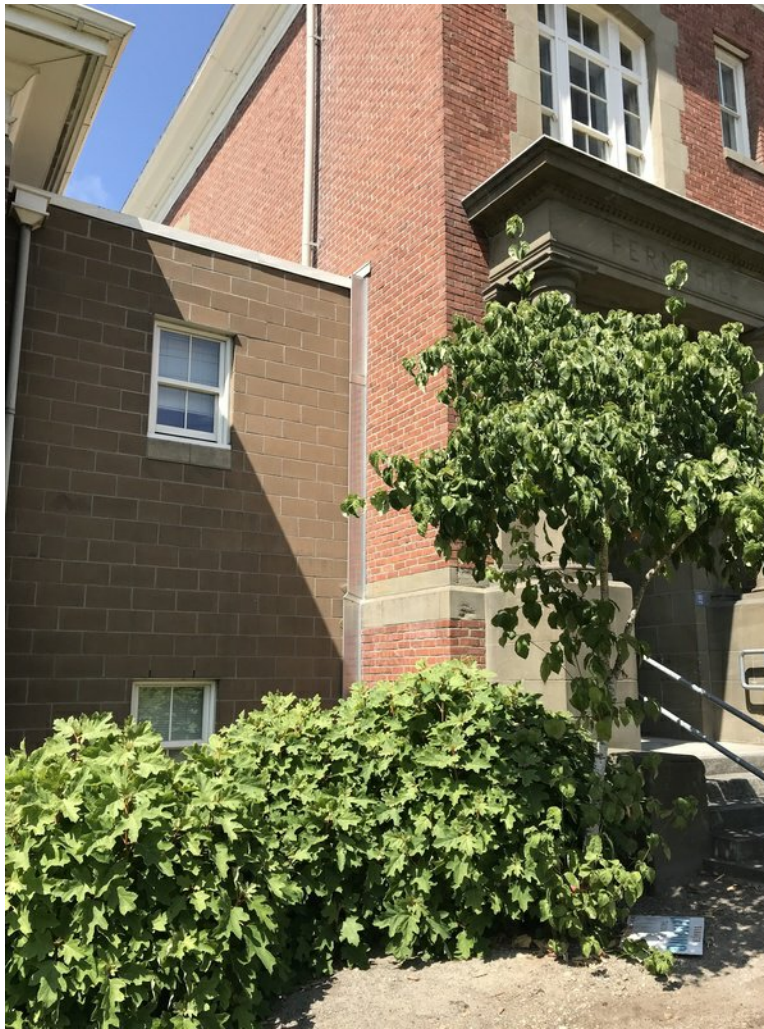
Deficiency	Description
Adjacent Buildings	Calculated minimum clear distance of 26.5 ft height x 1.5% = 4.8 inches, which is close to the gap provided. (North side two inch seismic joint and south side four inch seismic joint between 2006 construction and earlier construction.) Exact height of 2006 roof unknown.
Shear Stress Check	Quick Check procedure indicated that west cmu walls may be overstressed. Further study is recommended. May require cmu wall strengthening such as braced frames or shotcrete.
Proportions	A quick calculation indicates the first and second stories comply, but the top story does not.
Cross Ties	Cross ties between diaphragm chords for the 1911 building were not observed in the field or detailed in the 2006 structural drawings. Additional straps may be required.

Figure 1-3. Fern Hill seismic joint between 1911 construction and later addition

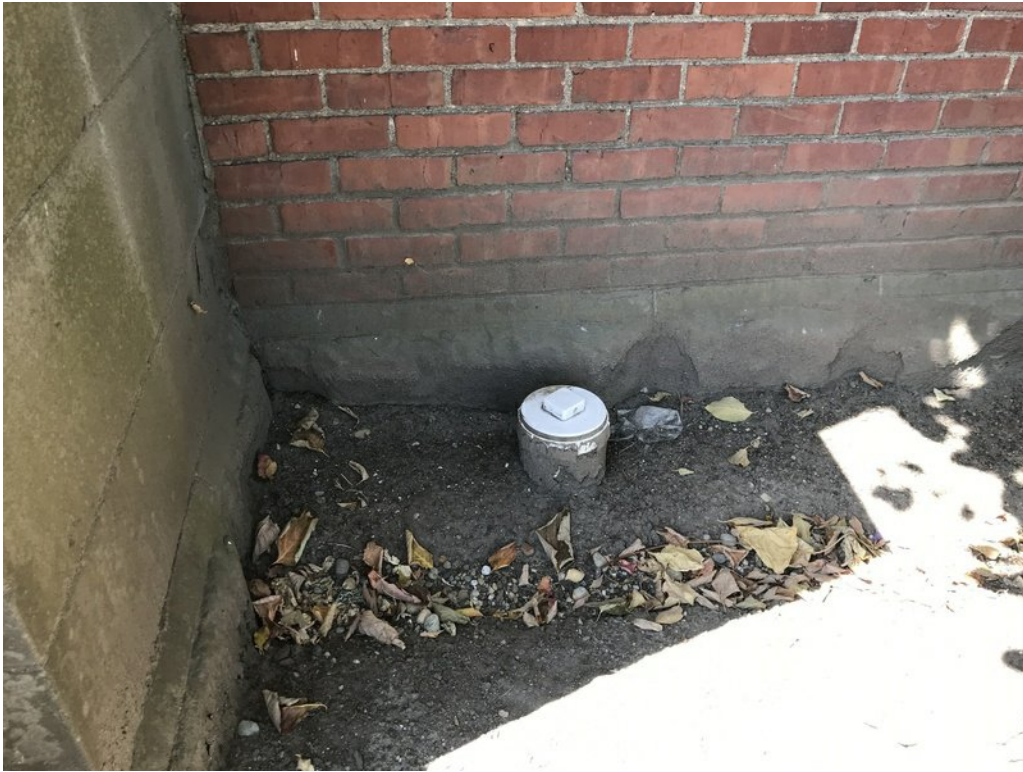
Figure 1-4. Fern Hill east side - exposed foundation wall

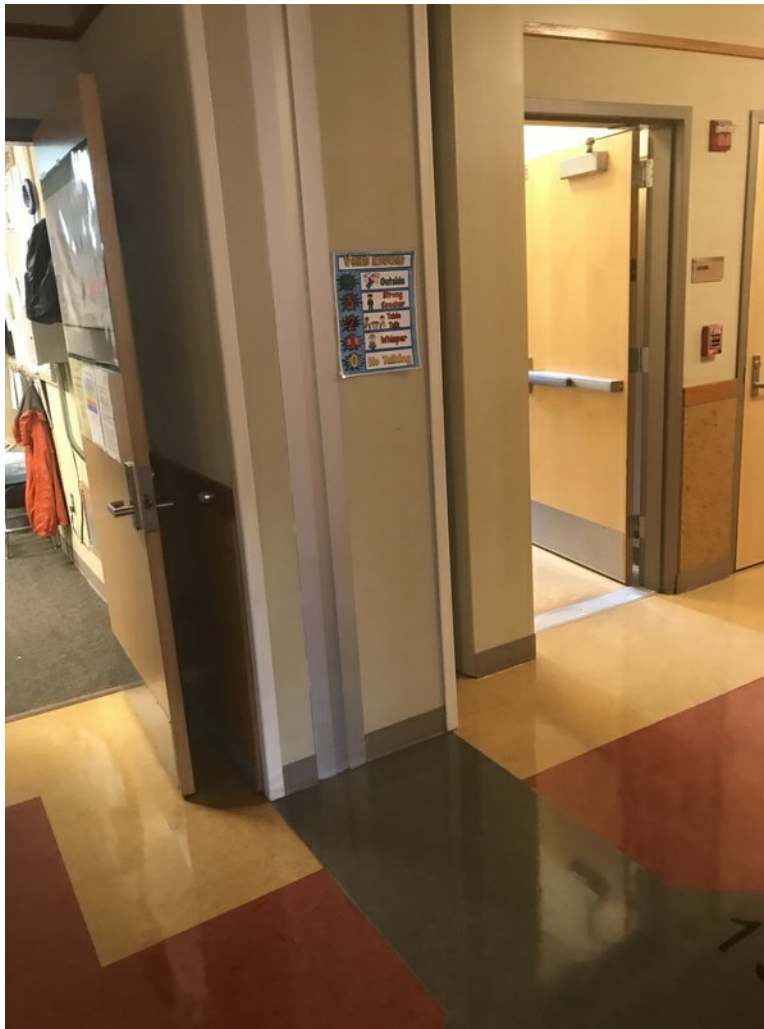
Figure 1-6. Fern Hill Seismic Joint - inside building

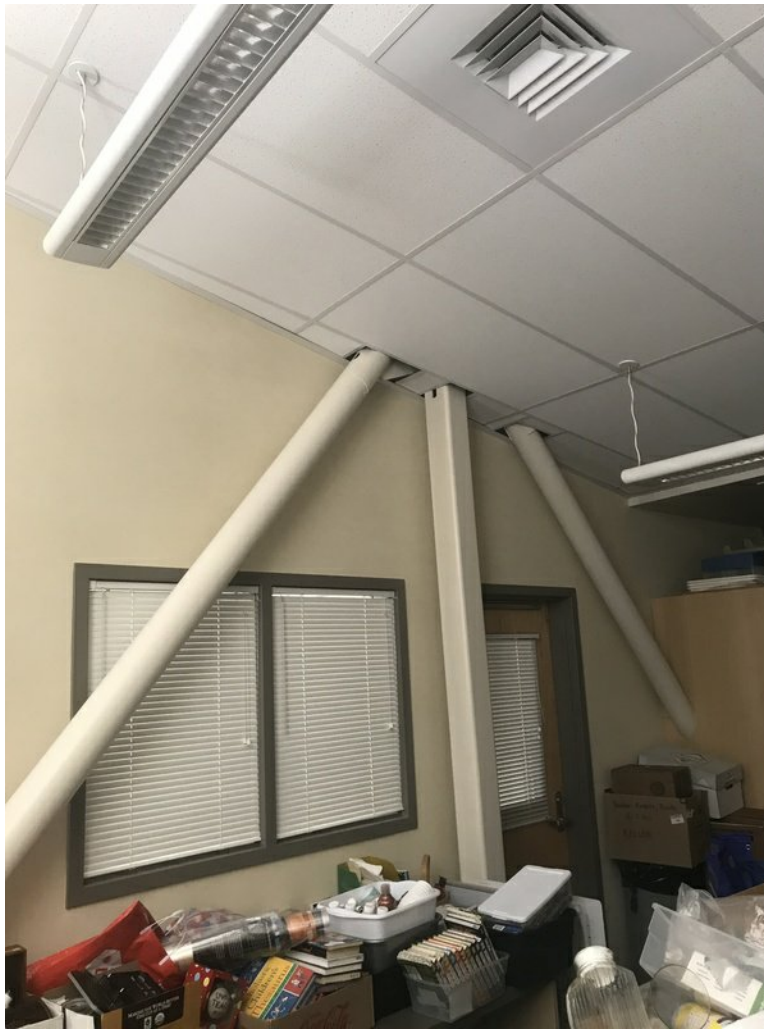
Figure 1-7. Fern Hill Braced Frame

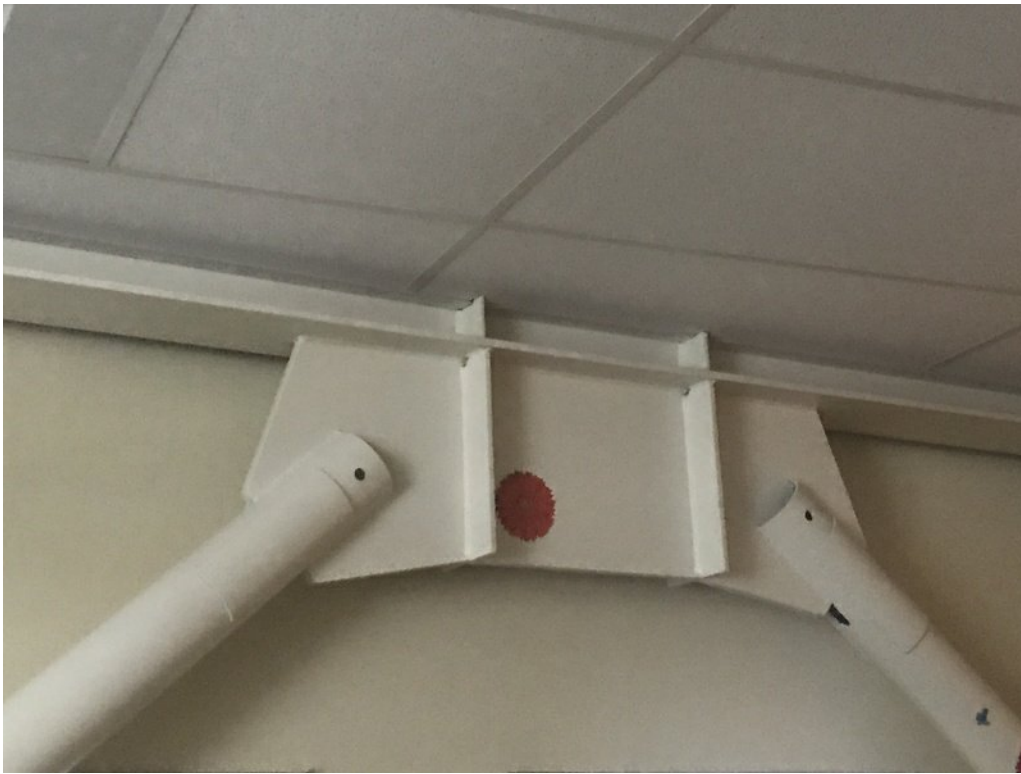
Figure 1-8. Fern Hill braced frame connection

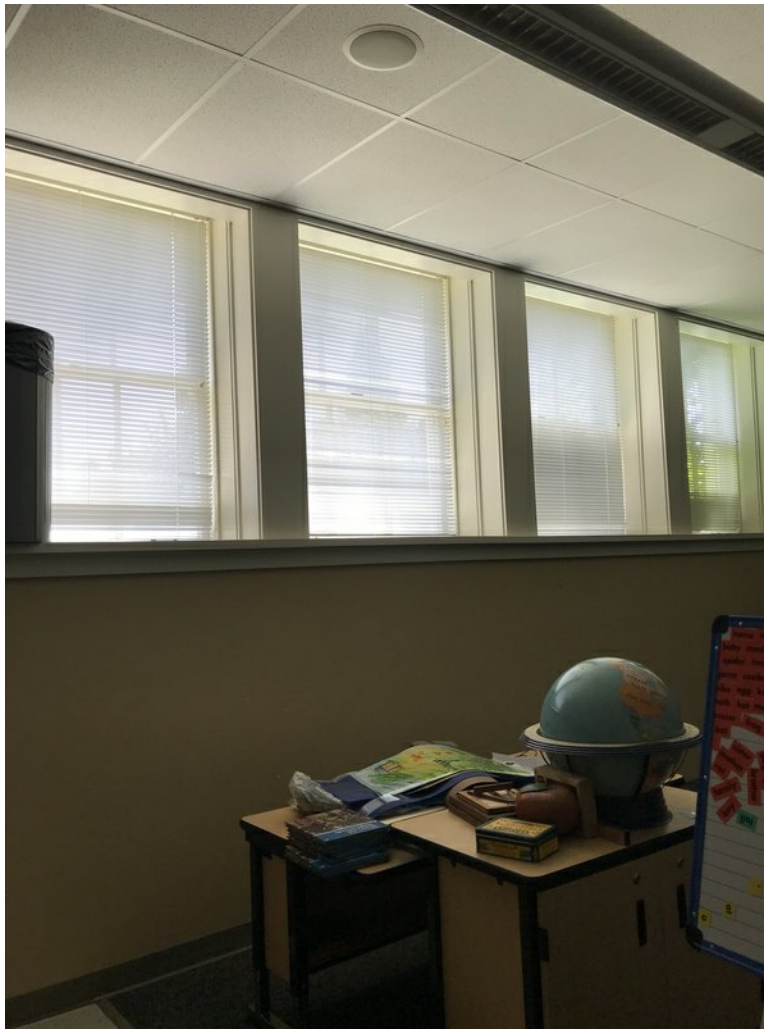
Figure 1-9. Fern Hill lower level classroom windows

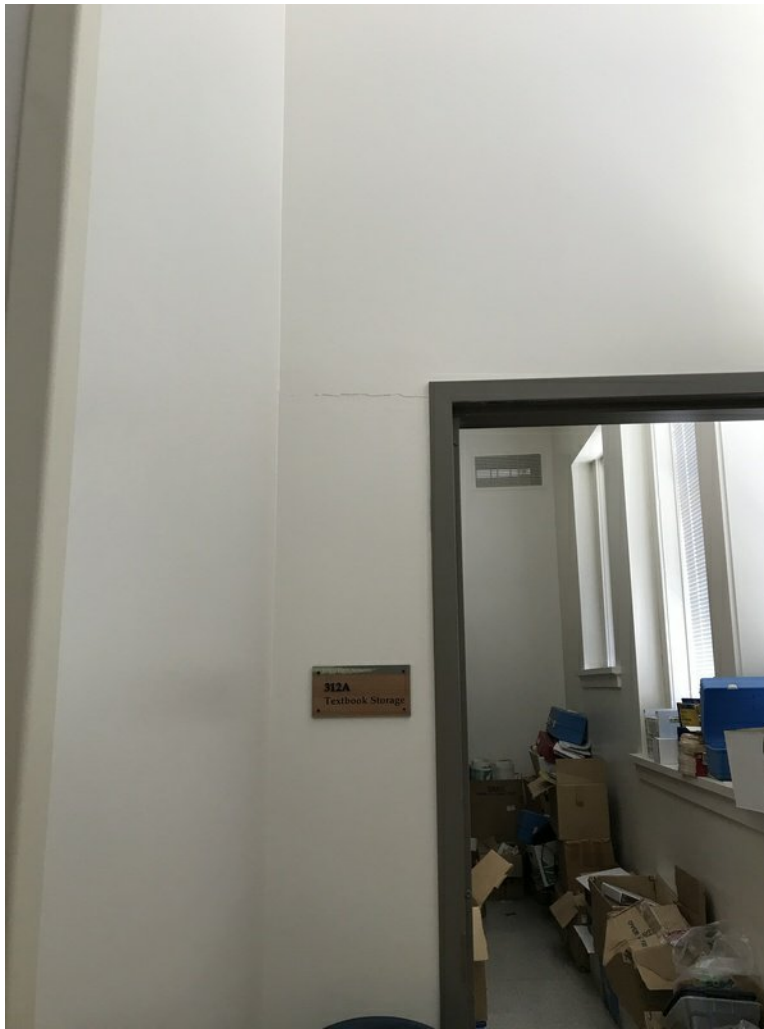
Figure 1-10. Fern Hill crack in interior wall

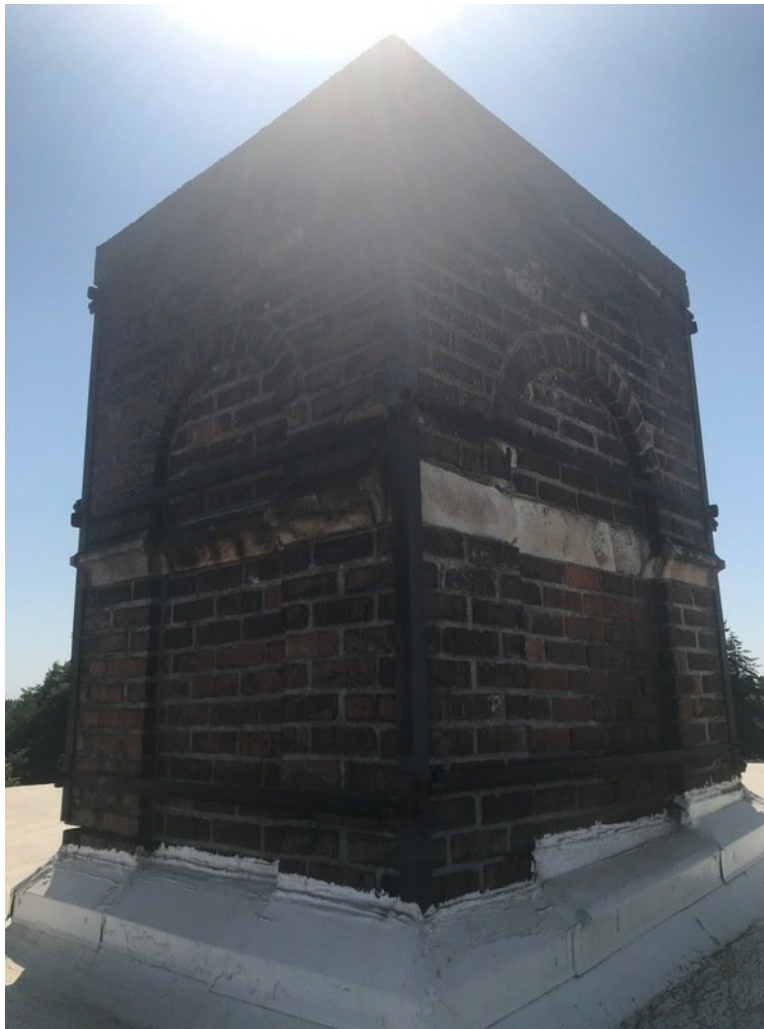
Figure 1-5. Strapping of chimney

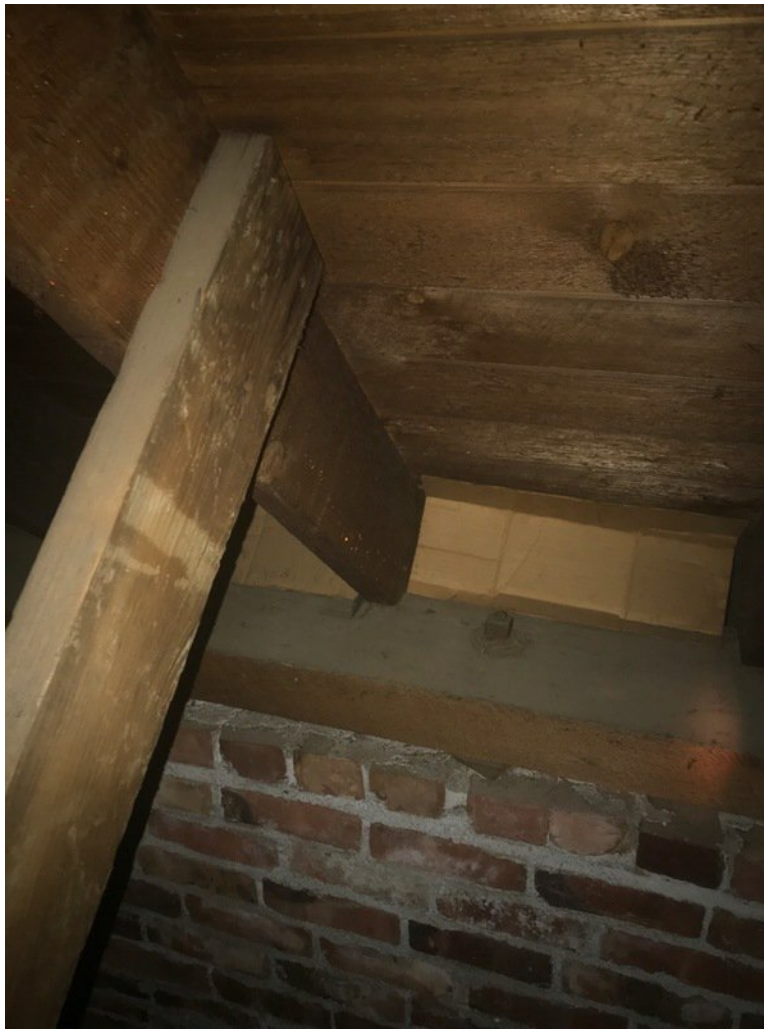
Figure 1-9. Attic - sill plate anchorage
